Fire destroys firefighters protective clothing - and prevents his injury

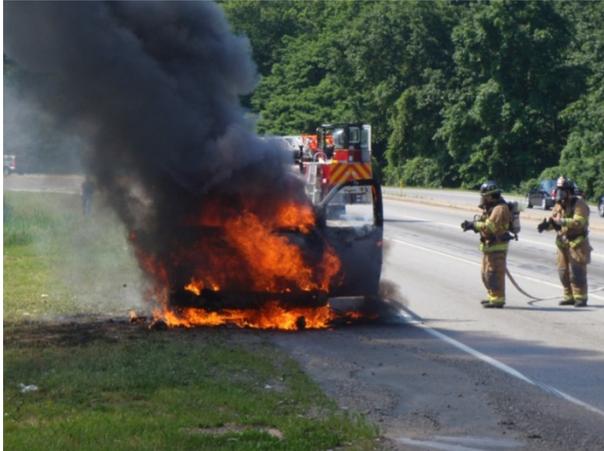
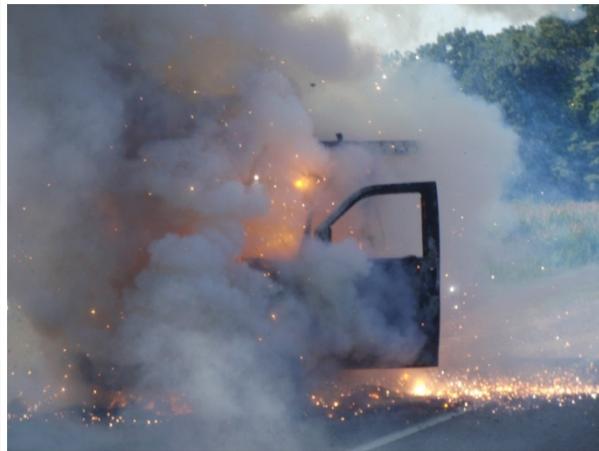
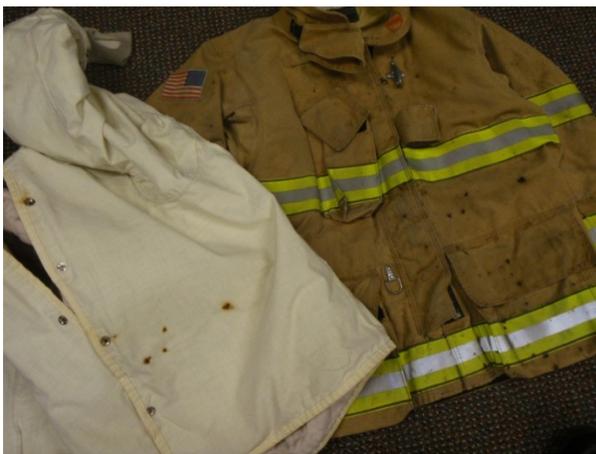
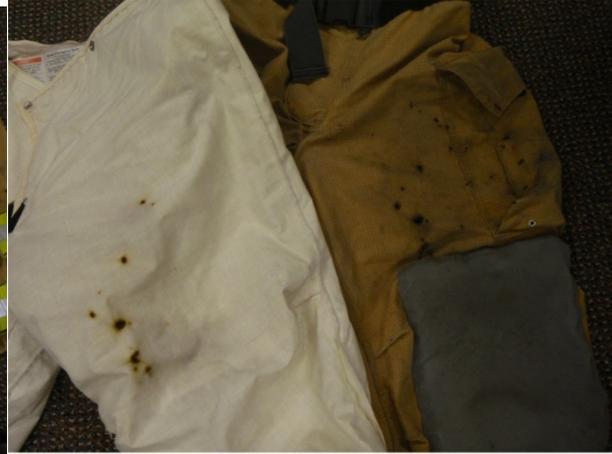
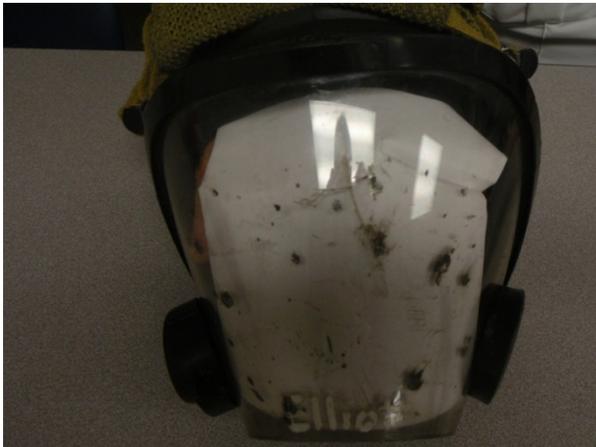
Your Sylvania fire fighters pictured below were preparing to attack a van fire Wednesday. When water was applied, the magnesium (commonly used in engines and other areas of a vehicle) reacted violently as seen in the second picture. The nozzleman's gear was destroyed by this but because of the fact he was in full firefighting gear, he was not injured. As you can see in the other pictures, the magnesium burned through the outer shell and scorched the vapor barrier but never made contact with skin or uniform clothing. It also damaged his SCBA mask.
